Sustainable Infrastructure: The Elmer Avenue Neighborhood Retrofit

EDWARD BELDEN, MICHAEL ANTOS, KRISTY MORRIS, & NANCY L.C. STEELE

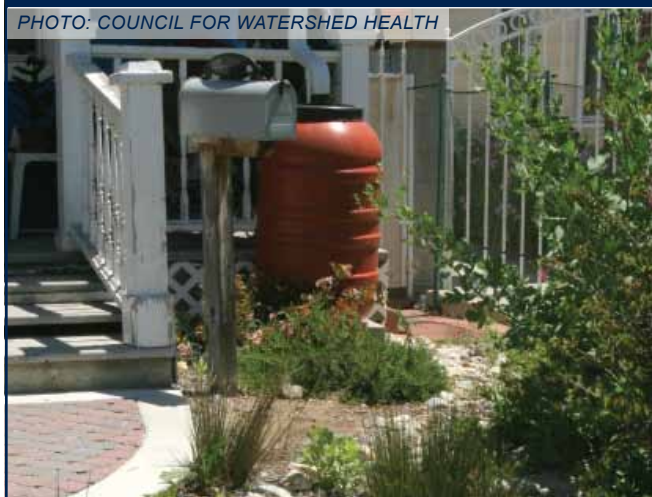
Figure 7. Residence Improvements

Community involvement continues today with residents helping to monitor the landscapes. Maintenance and training days for all residents are held quarterly on Saturdays to cover the items in the maintenance manual. The manual provided to each house has a calendar of activities to be performed, from cleaning the inlets to trimming native plants, and includes contact numbers for additional resources (Figure 7).

- Vegetated bioswales running the length of Elmer Avenue on both sides of the street
- Permeable pavers
- Dry swales
- Rain barrels
- Native and drought-tolerant landscaping to replace existing lawns

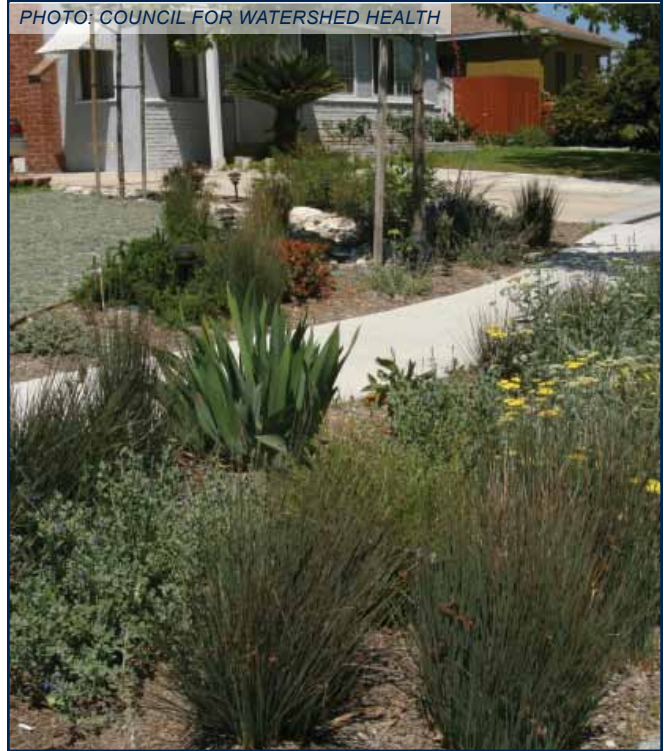
Figure 14. Residence and Right-of-Way: Post-Project

Monitoring along Elmer Avenue and the Paseo will provide valuable information on the performance of the various BMPs, the influence of these types of demonstration projects on the community, and additional information on what works and what is needed to convert the urban landscape into a healthy watershed (Figure 14).
